MSC-07007

APOLLO 16

30-DAY FAILURE AND ANOMALY LISTING REPORT

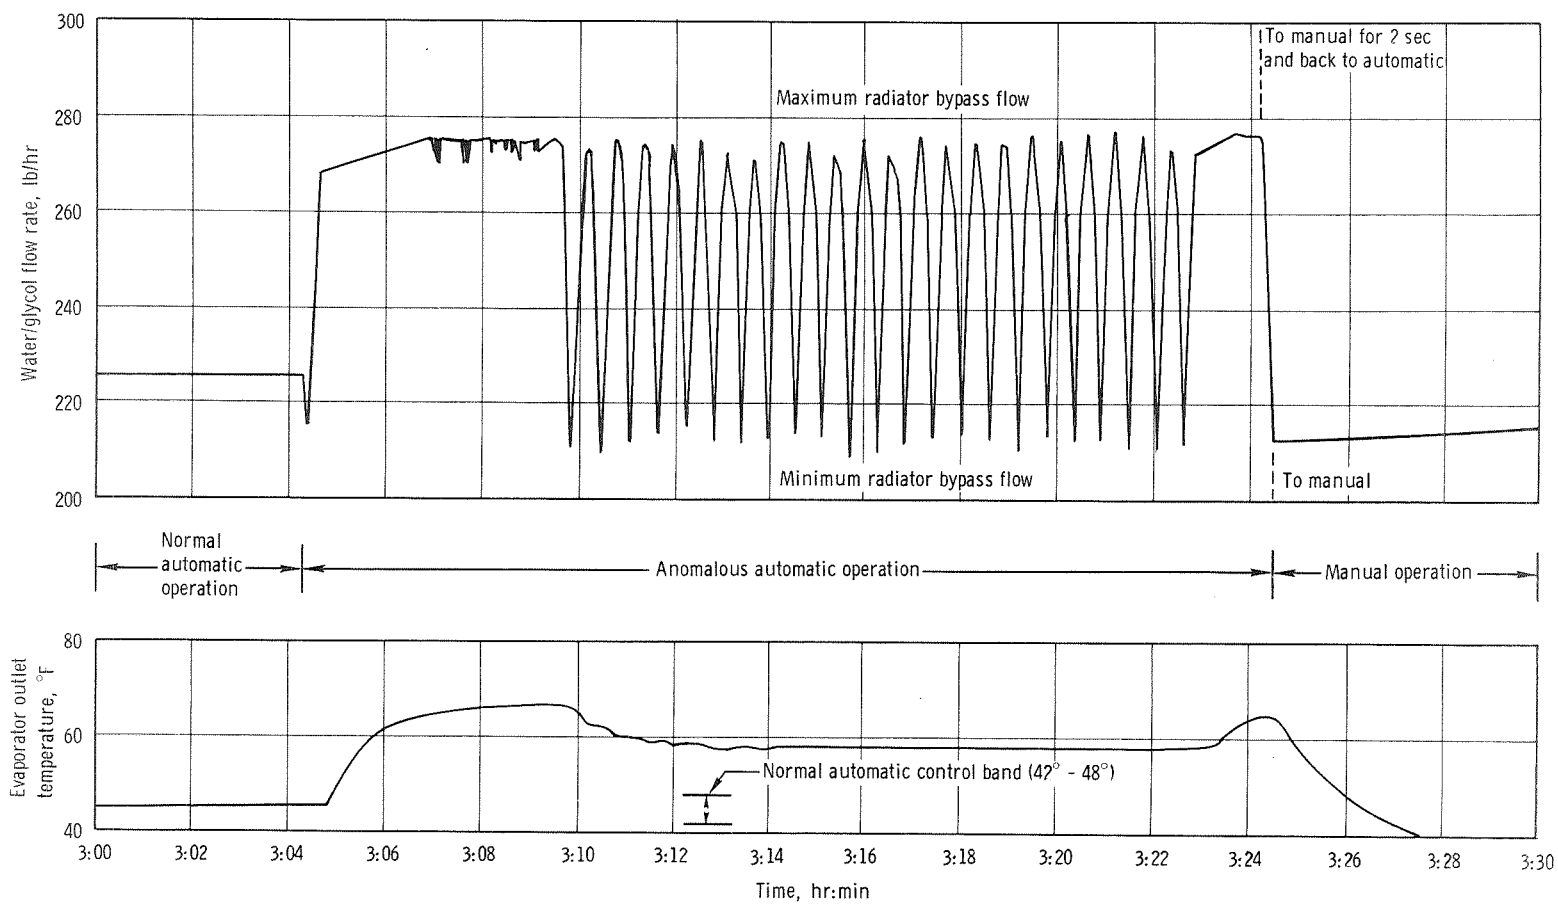
Figure 2-2. - Evaporator outlet temperature and system flow rate during anomalous period.

About 3 hours into the mission, the water/glycol temperature control circuit (fig. 2-1) malfunctioned in the automatic mode. The malfunction allowed an excessive amount of hot water/glycol to bypass the radiator causing the mixed water/glycol temperature to exceed the upper control limit of 48° F. After remaining in this maximum bypass position for 5 minutes, the temperature control valve cycled regularly between maximum and minimum flow to the radiators for about 14 minutes before stopping again at maximum bypass. The control was changed to manual and back to automatic to restart the valve operation and, finally, left in manual at the desired valve position. Variations in the evaporator outlet temperature and total system flow rate for the period are shown in figure 2-2. Control valve operation is evident from the variation of system flow rate. Total flow rate increases as the flow control valve opens since the total system pressure drop decreases.

The temperature control valve was subsequently positioned manually several times to maintain acceptable coolant loop temperatures under various thermal conditions. During two attempts to position the valve automatically (before and after the transearth extravehicular activity) the valve appeared to position correctly but, only for a short time.

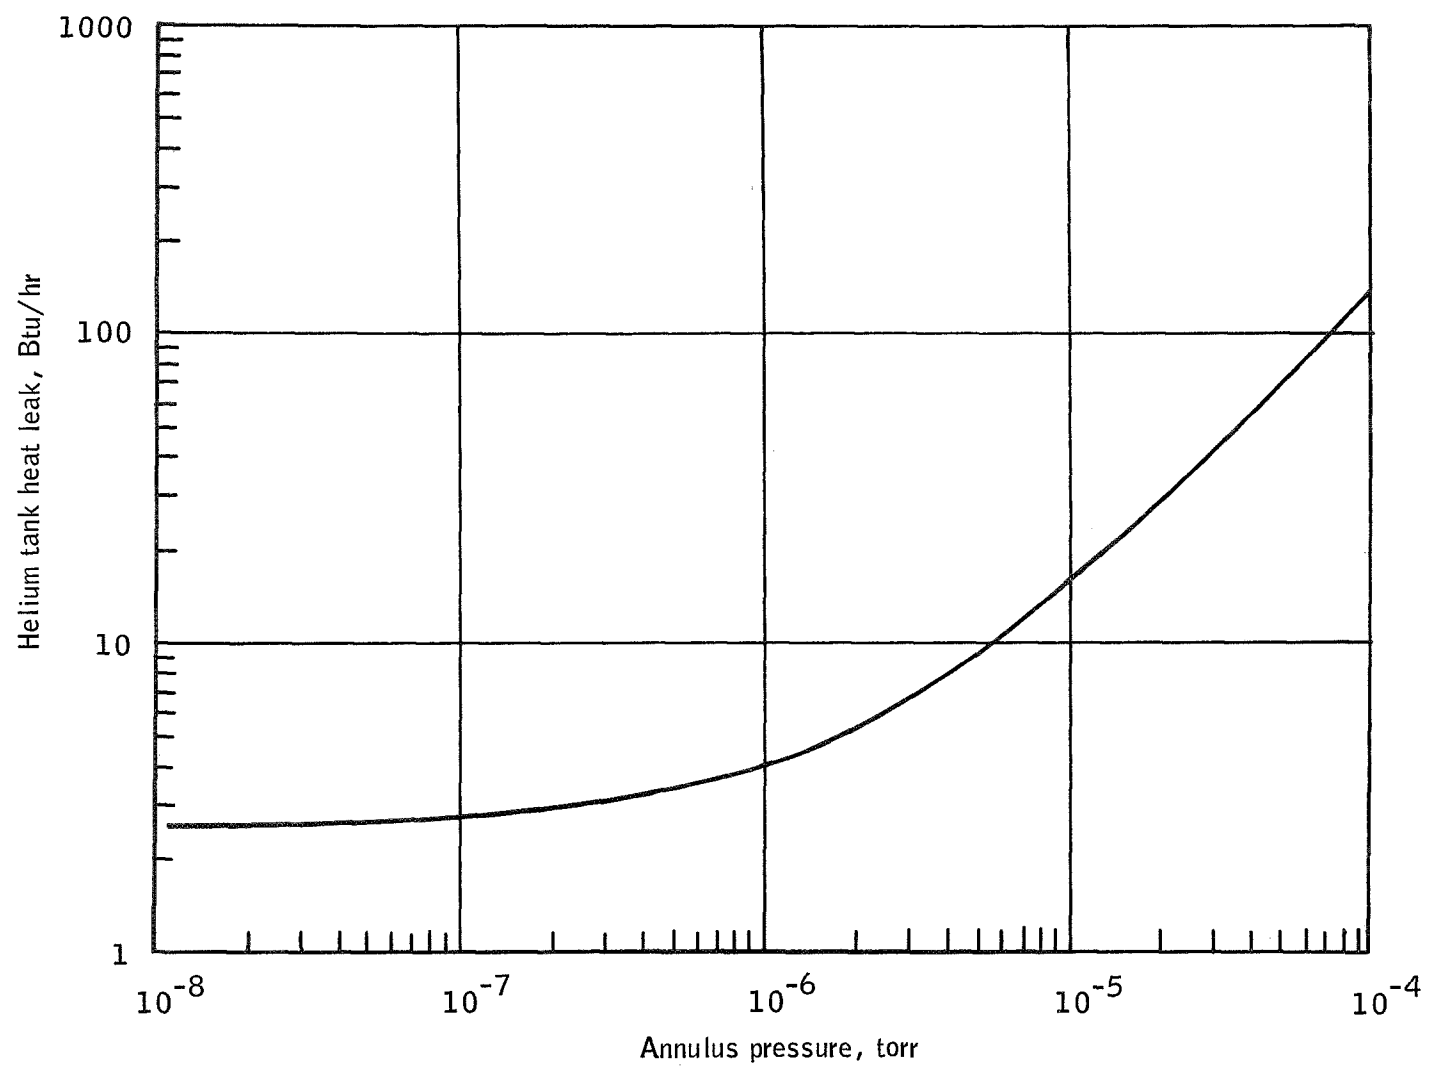
Figure 2-8.- Hydrogen tank heat leak as a function of annulus pressure.

The insulation for this tank consists of several layers of gold-coated H-film in a vacuum annulus that is formed between the inner pressure vessel and the outer shell (fig. 2-7). The primary insulation system is, however, the vacuum annulus. Degradation of this insulating vacuum will cause a significant increase in the heat leak into the tank as shown in figure 2-8. The analysis indicates that the high initial heat leak resulted from a degradation of this vacuum by approximately one decade (approximately 10^{-6} to 10^{-5} torr). This degradation could have been caused by either of two occurrences:

Analysis is continuing to further investigate both of these possibilities. In addition, studies are continuing to verify that pressure oscillations did not contribute to the high heat leak.

A hydrogen leak into the annulus has been ruled out because a hydrogen leak should have continued throughout the mission, and would have caused the heat leak to remain at a high level. The qualification vibration test levels and procedures for the hydrogen tank have been reviewed and are adequate.

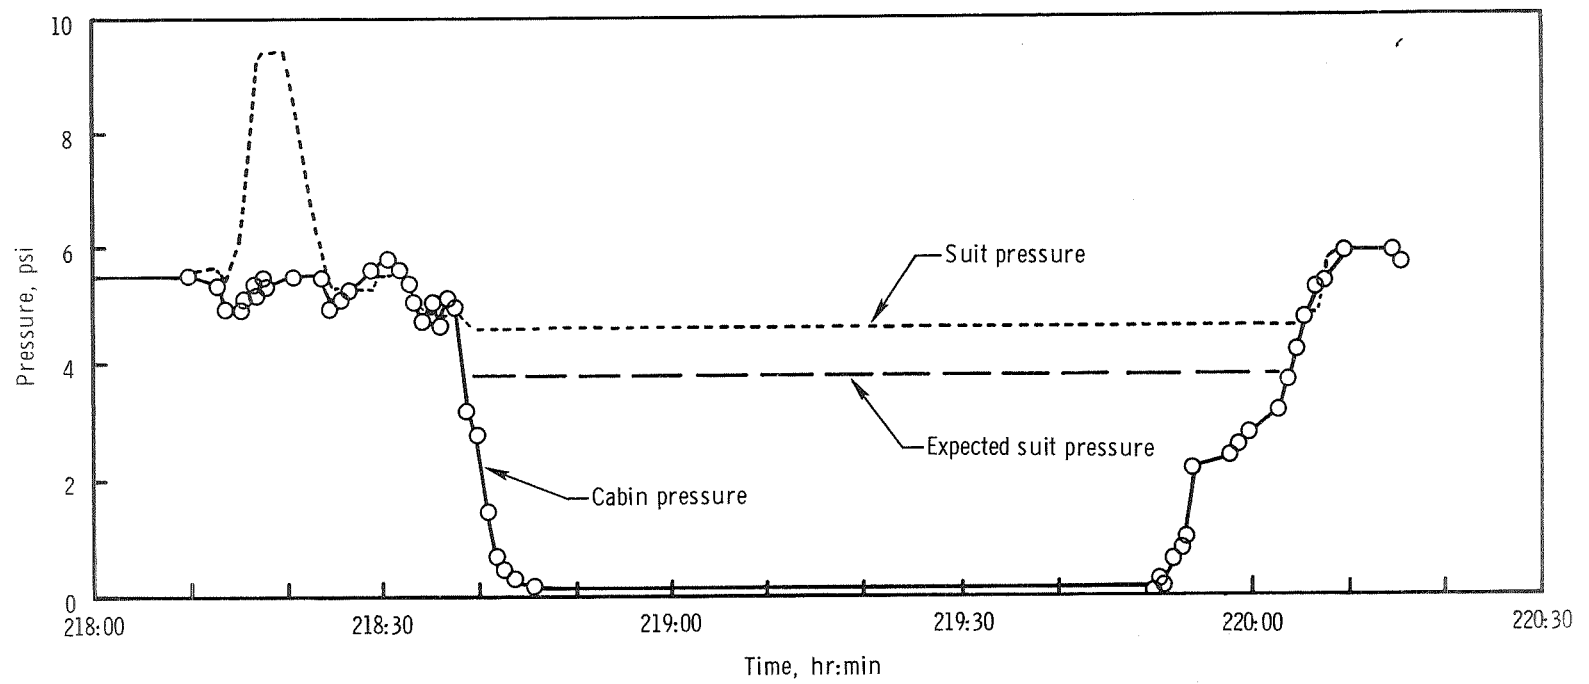
Figure 2-12. - Suit loop pressure data.

Postflight tests of the transducer are scheduled.

This anomaly is open.

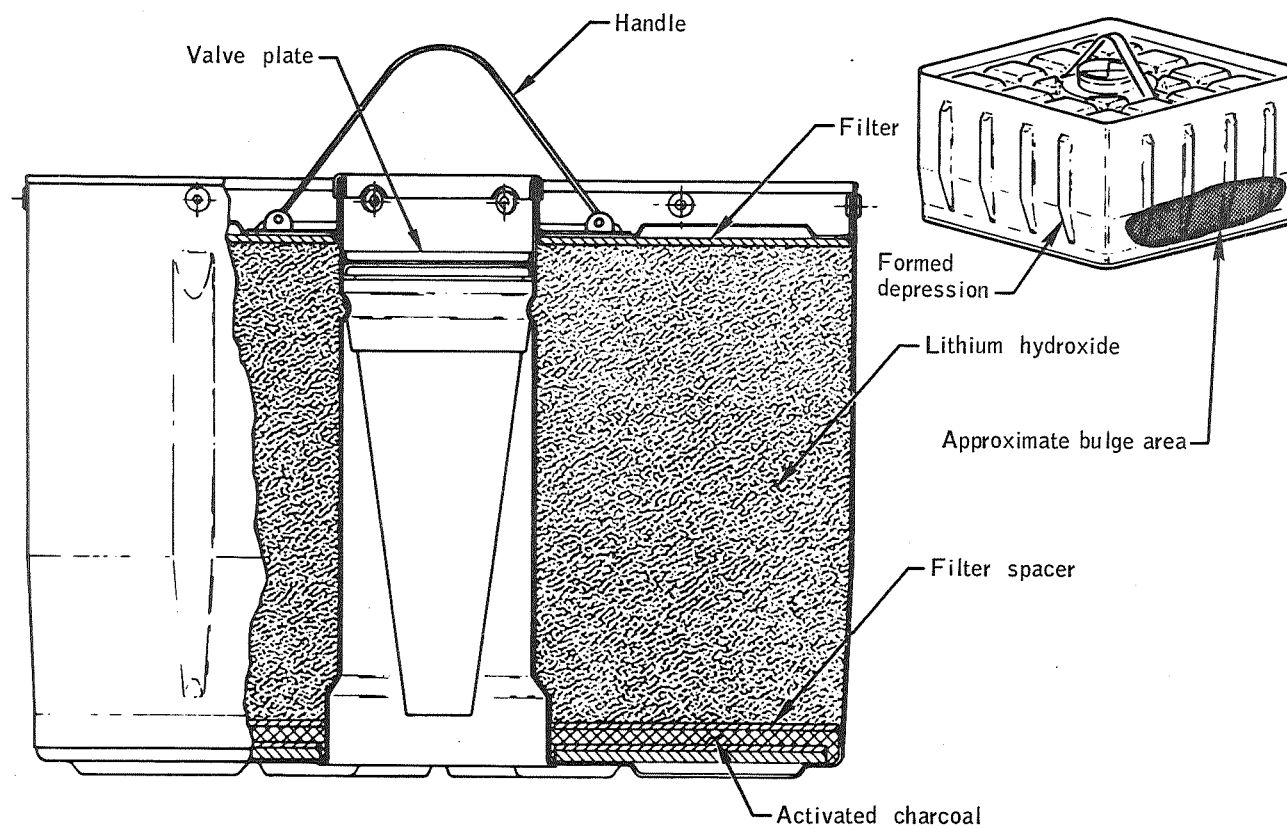
Figure 2-14.- Lithium hydroxide element.

Although the first element was jettisoned with the lunar module, the second element was returned for analysis. Postflight inspection of this element revealed a bulge (fig. 2-14). To accomodate some element swelling, the elements and environmental control unit canister are sized to provide a minimum clearance of 0.030 inch on all four sides of a new element when installed. In addition, all flight elements are fit checked in each canister side with 0.030-inch-thick shims in place prior to launch and removal force is recorded (not to exceed 30 lb). However, the exterior skin of the element has little rigidity and "oil-cans" very easily.

Postflight testing is being performed on the sticking element.

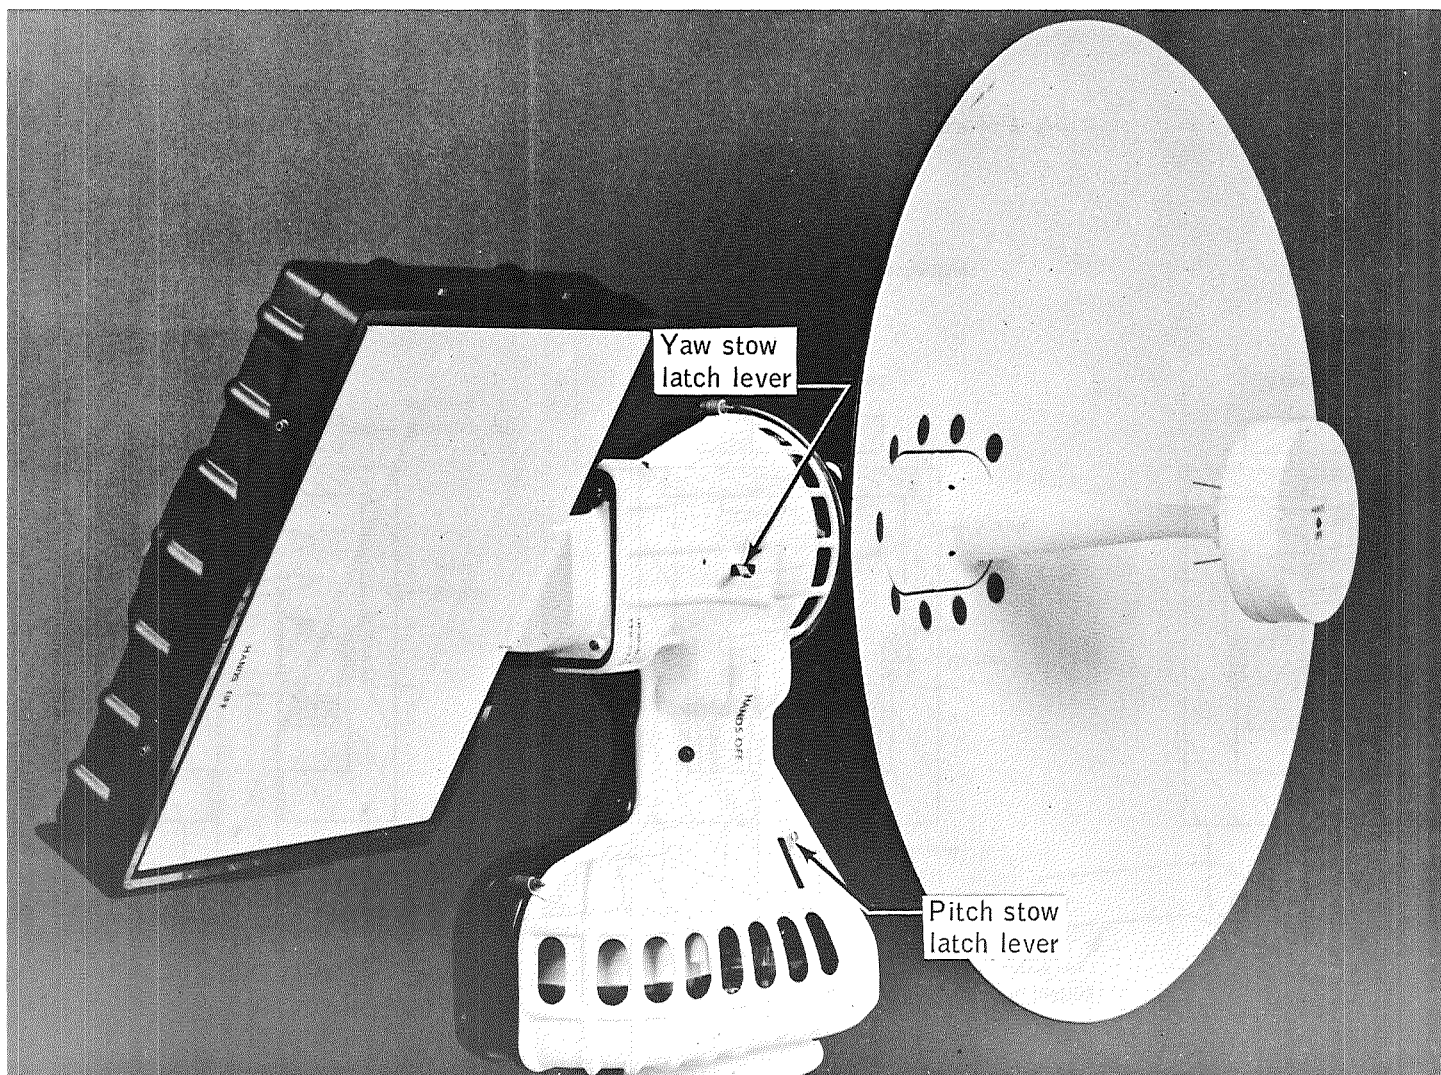
Figure 3-4.- Lunar module S-band steerable antenna.

The S-band steerable antenna (fig. 3-4) would not move in the yaw axis during initial activation. Several unsuccessful attempts were made to operate the unit using both the manual slew and auto track modes. The antenna was used in lunar orbit for a short period by changing the vehicle attitude to point the antenna at the earth.

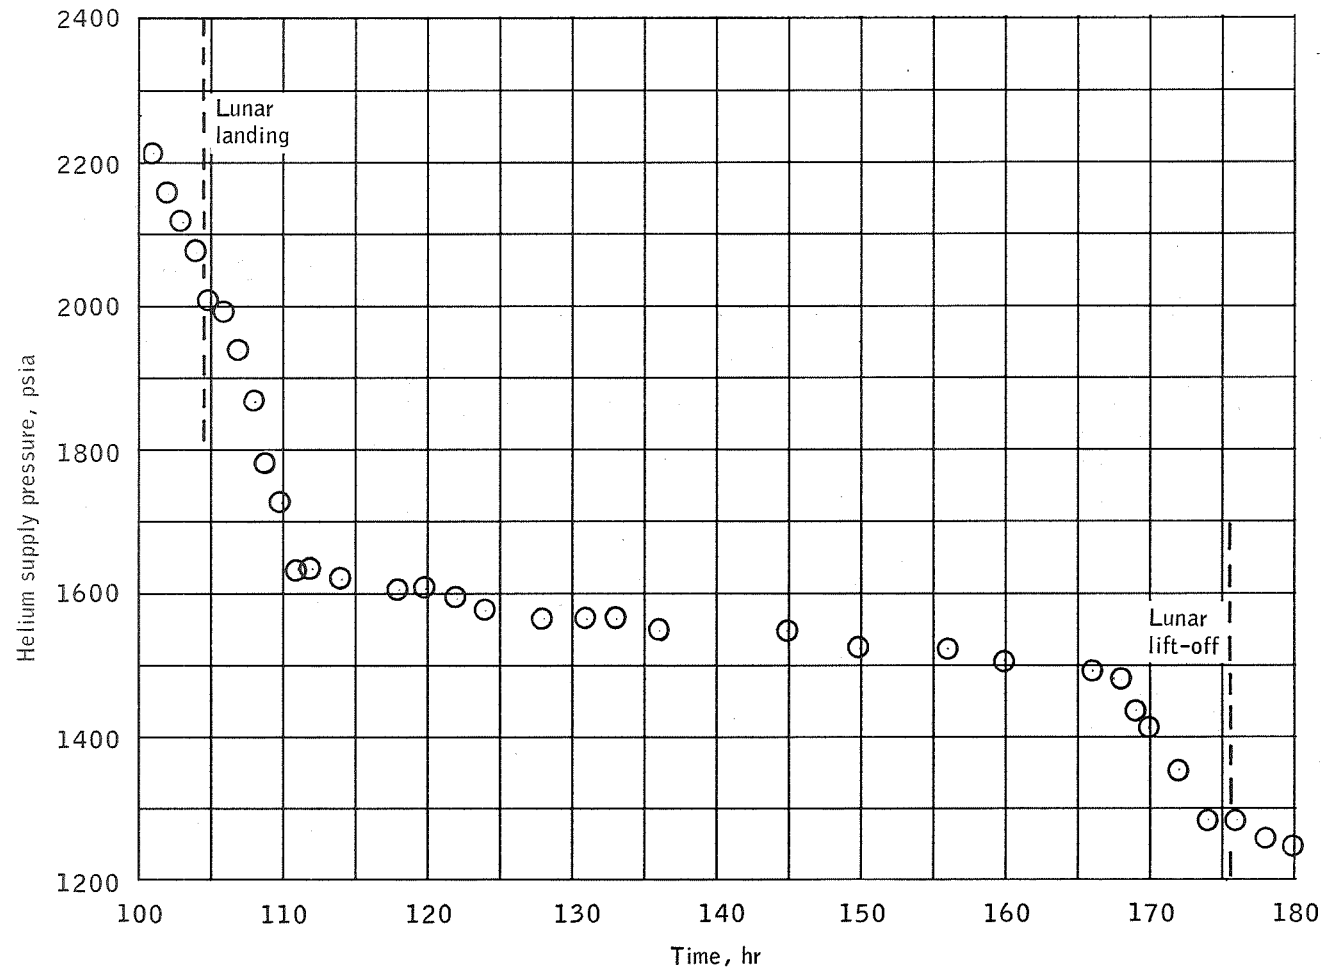
Figure 3-8.- Helium supply pressure for reaction control system during lunar stay.

During pressurization of the system at about 95:00, the regulator outlet pressure in system A (fig. 3-7) increased beyond the maximum specification limit. The normal pressurization is characterized by a sharp increase from the nominal pad pressure, in the interval of 1 to 2 seconds, to the normal regulator outlet pressure. The outlet pressure of system A, after reaching the normal value of 184 psia, continued to rise at approximately 10 psi/minute, a condition which clearly indicated the existence of internal leakage in the regulator assembly. The helium leakage continued throughout the mission, although the leakage rate varied from essentially zero to a maximum of about 1100 scc/min (figs. 3-8 and 3-9). The regulator outlet pressure eventually increased to about 237 psia at which time the relief valves of system A started to periodically relieve the pressure to about 232 psia.

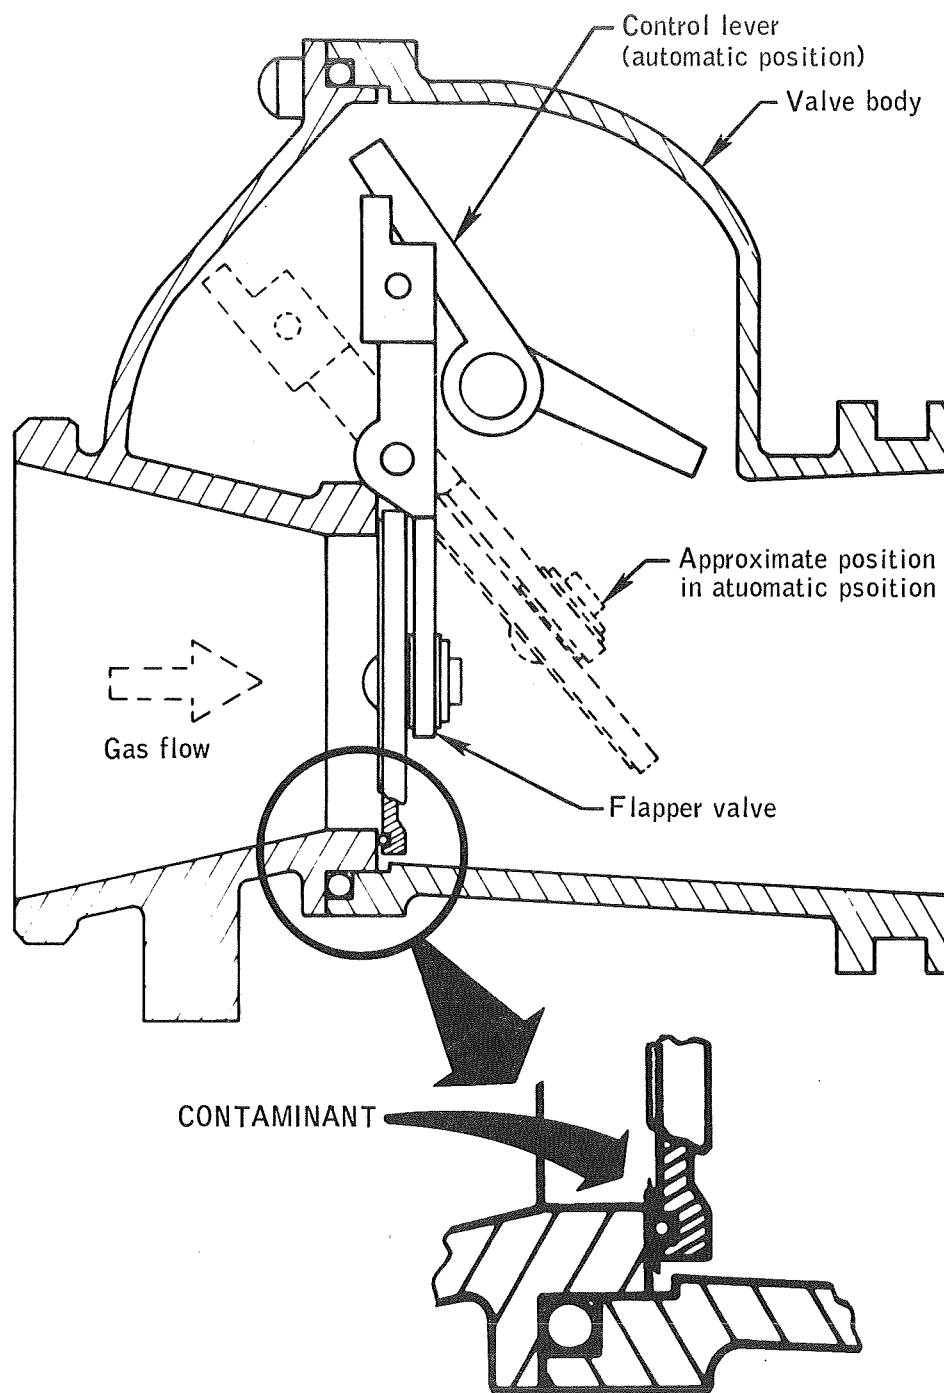
Figure 3-13.- Cabin gas return valve.

Since the valve functioned properly upon activation and again late in the lunar stay, the apparent cause of the problem was contamination. There are two possible areas of contamination: material on the inlet screen or residue on the flapper seal (fig. 3-13). A suspected source of residue is the orange juice that leaked from the drink bags.

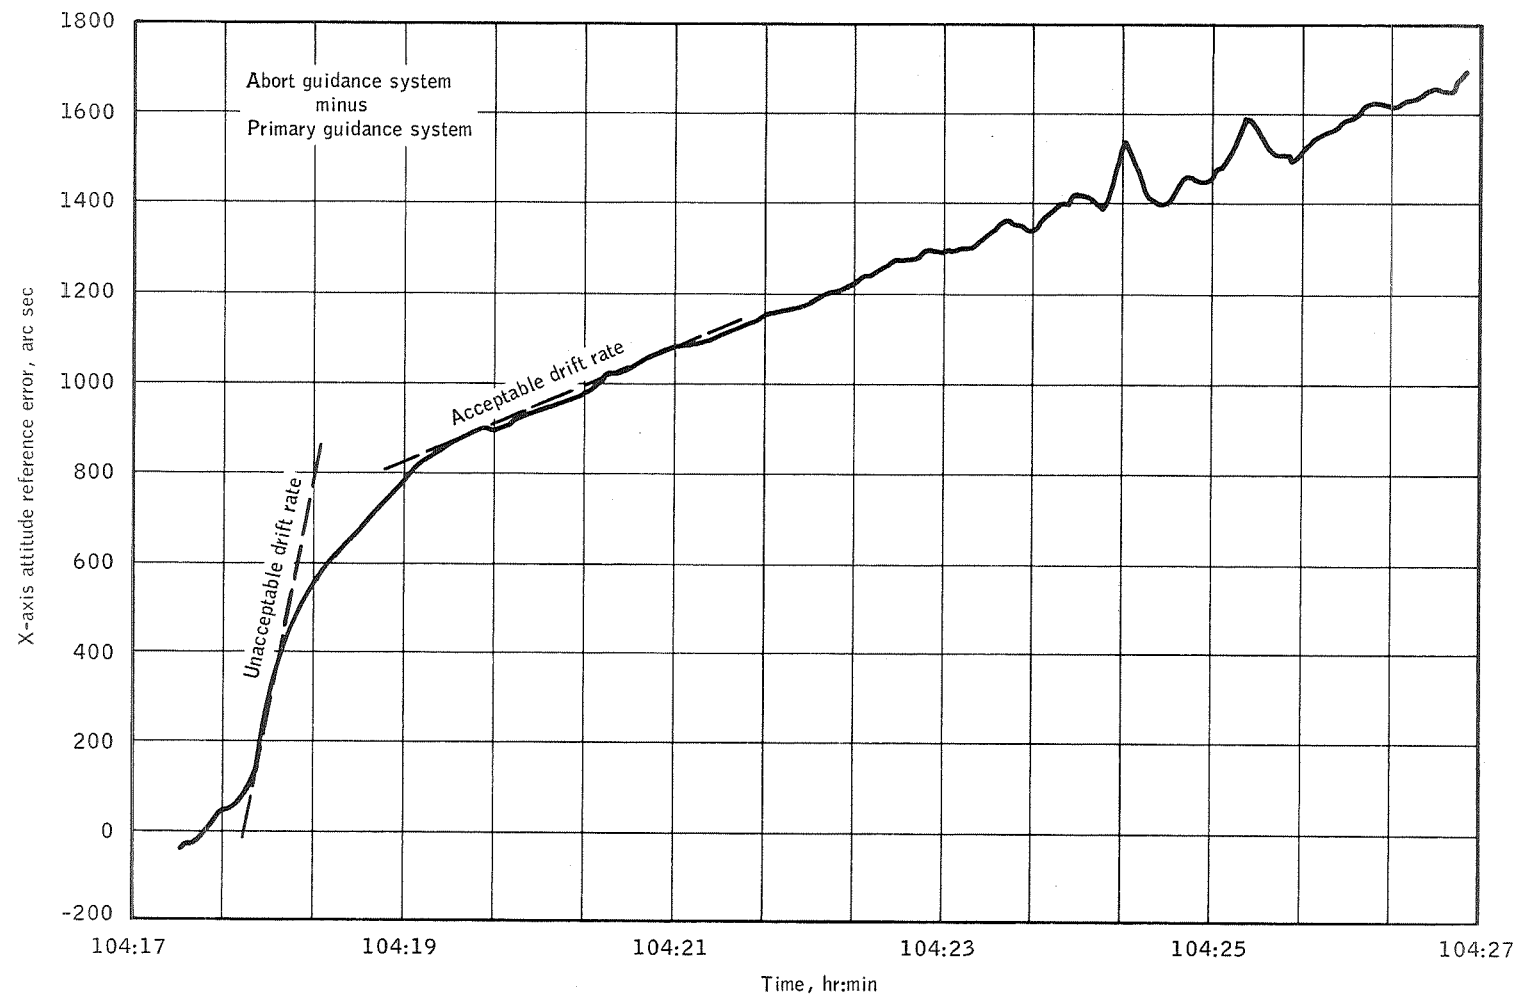
Figure 3-15.- Attitude reference error during descent.

Corrective action is dependent upon completion of detailed analysis.

This anomaly is open.

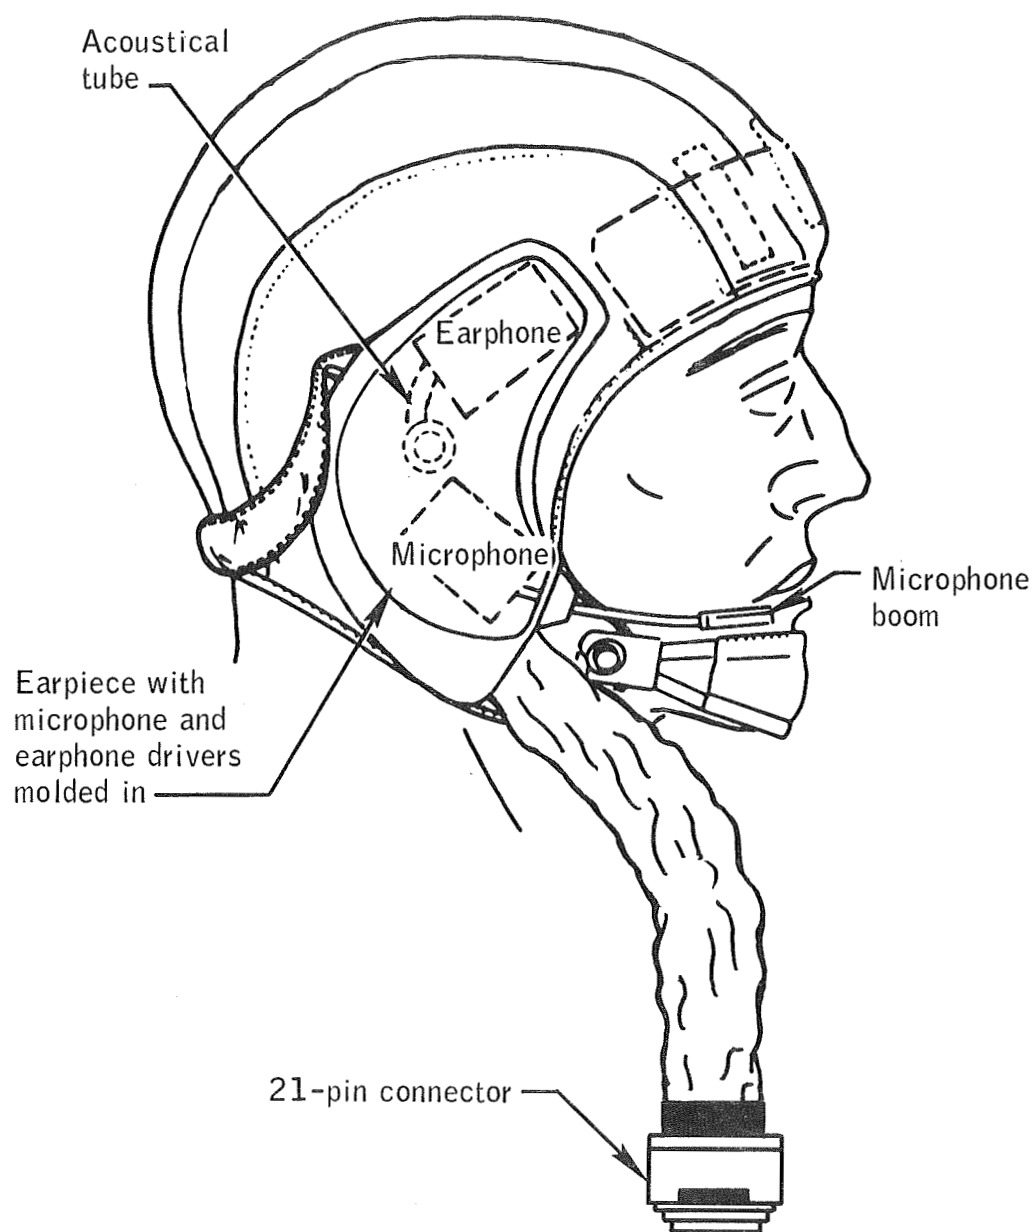
Figure 4-4.- Communications carrier.

During the communications check prior to the first extravehicular activity, the microphone audio signal from the Lunar Module Pilot's headset was too weak to operate the voice-operated keying circuitry in his extravehicular communications system. This was attributed to a loose tip on one of the communications carrier headset microphone booms plus orange juice blockage of the other microphone boom (fig 4-4). Postflight analysis will be performed to determine the cause of the loose microphone boom tip. The orange juice blockage will be evaluated as a juice bag problem.

During the transearth coast phase, the Lunar Module Pilot also experienced intermittent operation of his communications carrier headset earphone circuit. This condition was cleared by flexing the constant-wear garment harness near the 21-pin connector. Postflight tests will be made to reproduce the intermittent condition in the communications carrier umbilical and control head, the constant wear garment harness, and the communications carrier headset.

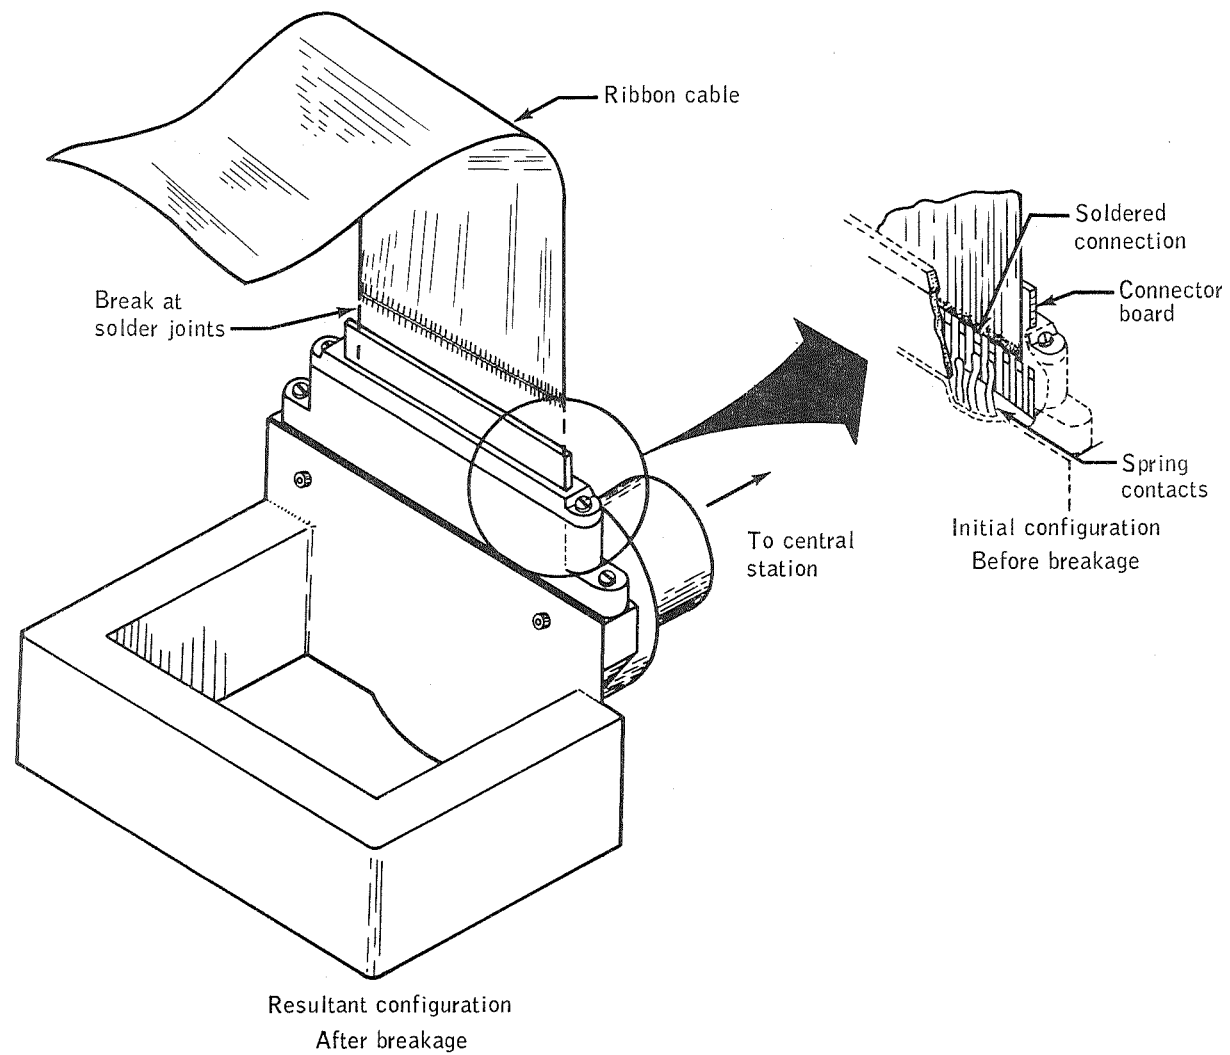
Figure 5-1.- Heat flow experiment connector.

The heat flow experiment is stowed on subpackage no. 2. Upon arrival at the Apollo lunar surface experiments package deployment site, the experiment is removed from the subpackage and the electrical ribbon cable is connected to the central station by an Astromate connector (fig. 5-1). The cable is bonded and soldered to a printed circuit board which is clamped in a connector. The cable-to-board joint is reinforced by two to four thicknesses of 0.5-mil Kapton tape.

Pull tests performed on the cable/Astromate connector configuration indicate the strength at the cable/board interface was 31 pounds. A modified joint assembly which includes a strain relief provision is under test (fig. 5-2).

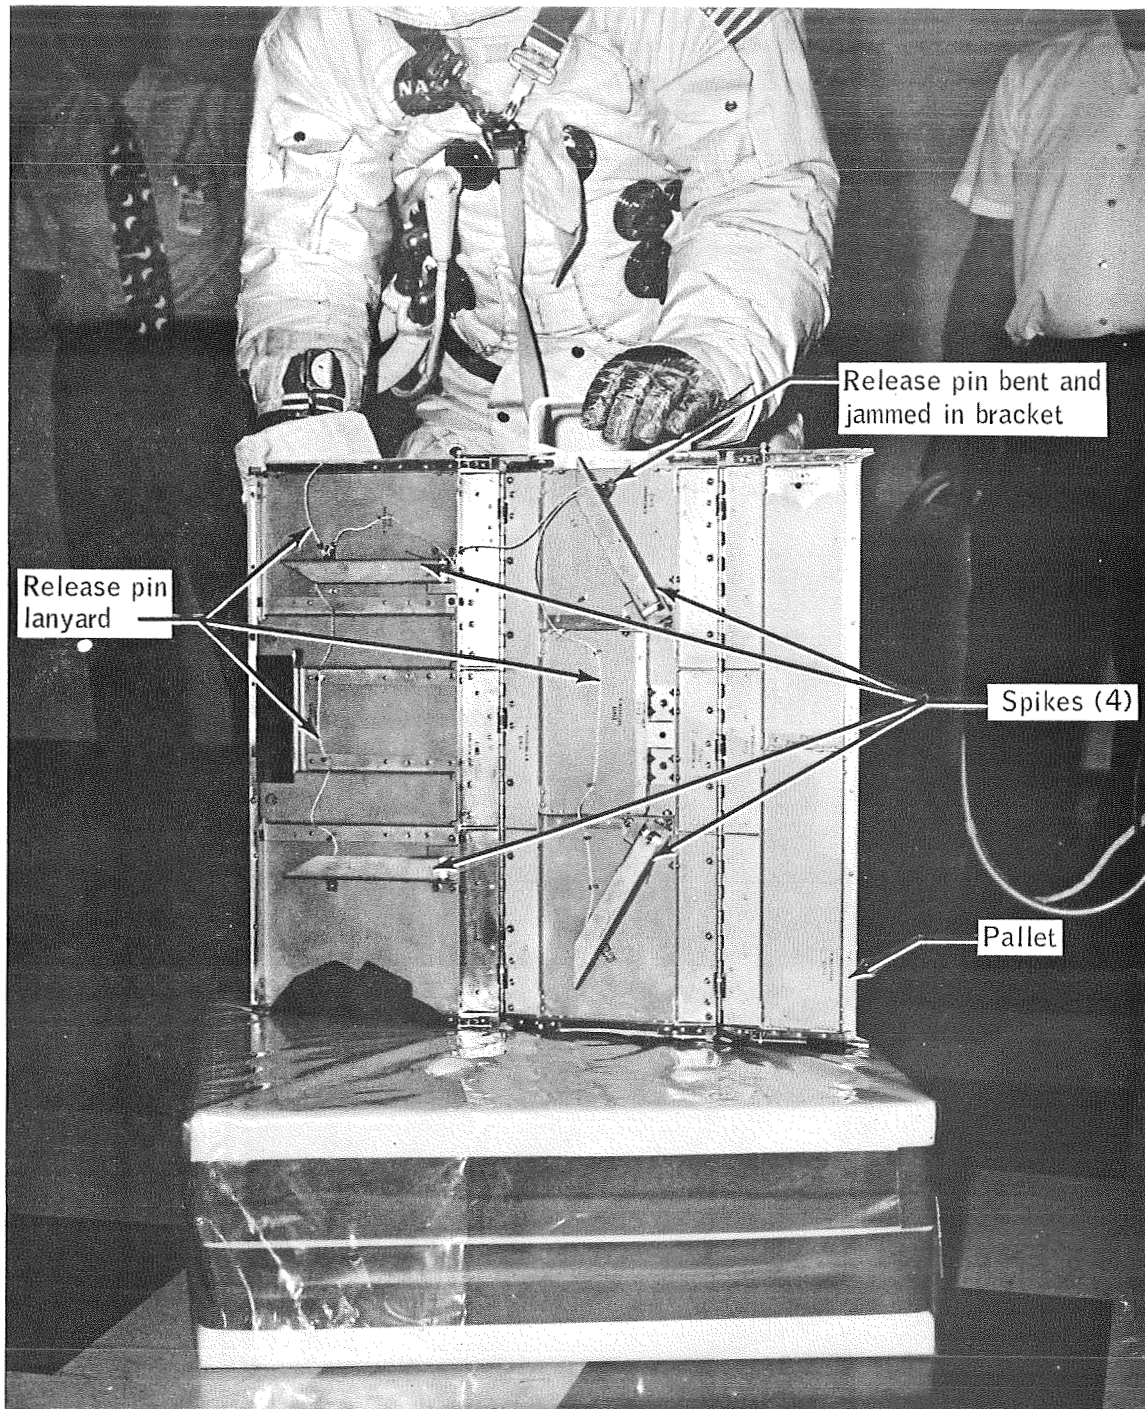
Figure 5-3.- Bottom view of active seismic experiment mortar package pallet.

The mortar package pallet assembly includes four 7-inch-long spikes (fig. 5-3) which deploy normal to the pallet when the release pins are removed. A spike can be deployed manually by shearing the pin; however, the crew was not adequately trained to implement this operation. When the pallet is properly positioned, the spikes are pressed into the lunar surface to provide additional stability to the platform.

Tests and analyses performed during the development of the pallet assembly indicate that three deployed spikes are adequate to provide stability. The Apollo 16 pallet was emplaced with the three spikes pressed into the lunar surface, and the crew reported the complete mortar package and pallet assembly was stable.

No corrective action is required as the experiment is not scheduled for another mission.

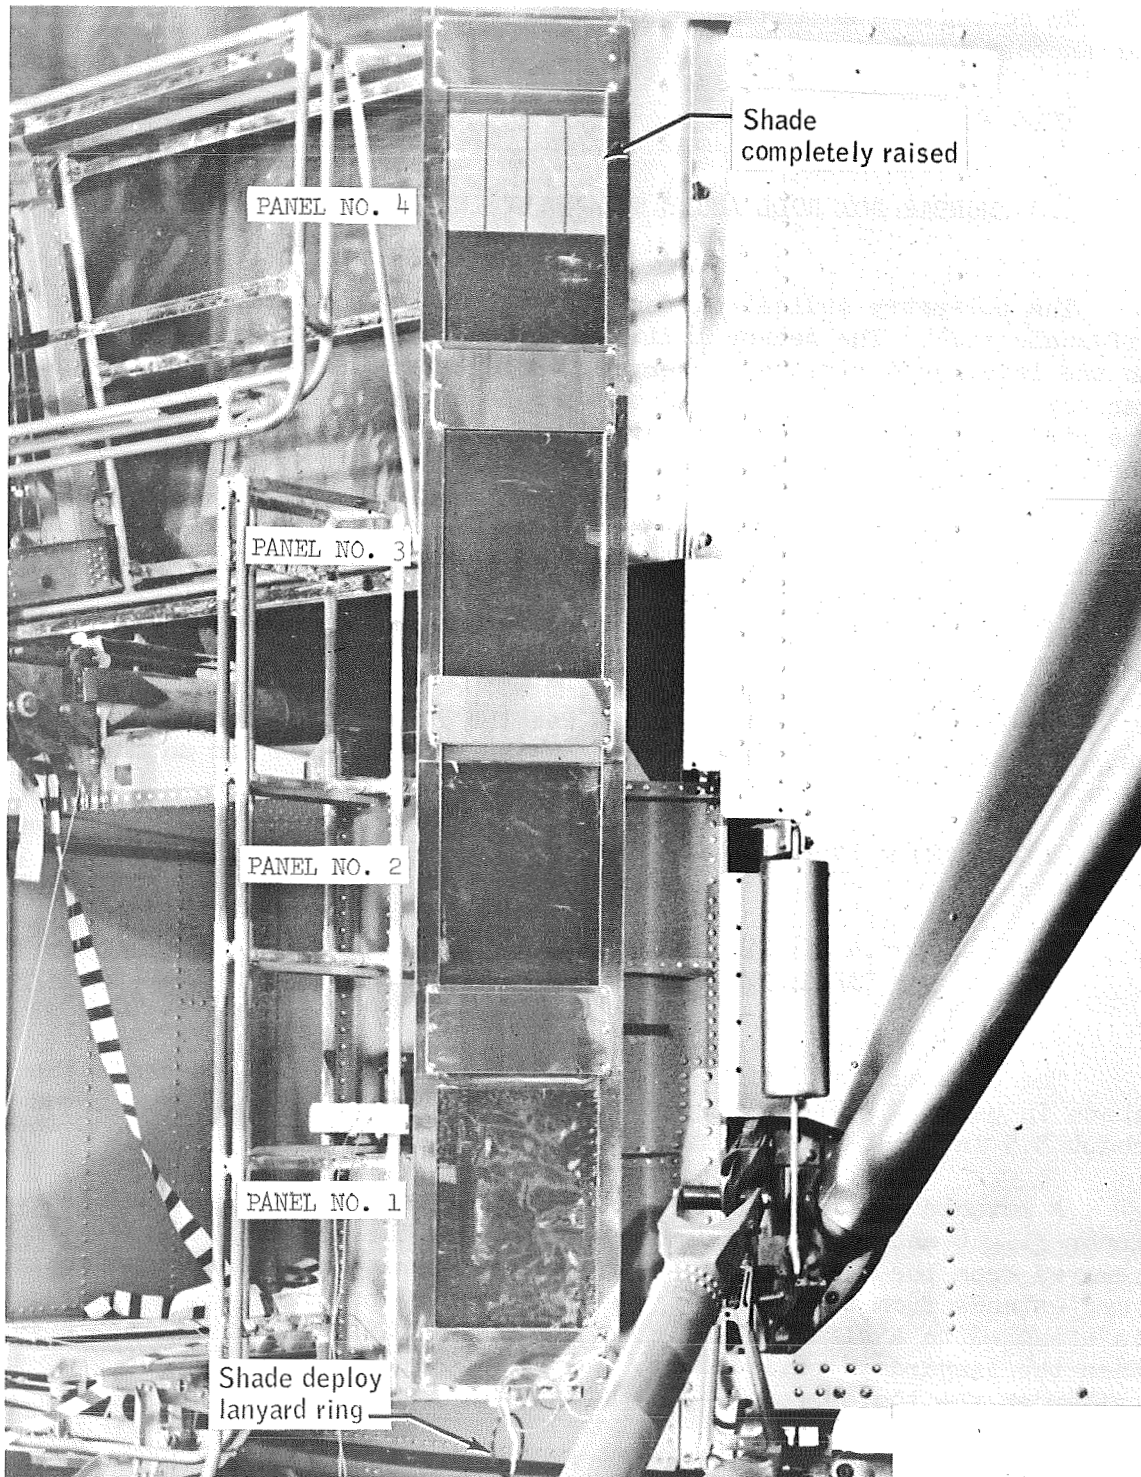
Figure 5-4.- Fully deployed cosmic ray detector experiment.

The Commander pulled the red-ring lanyard (fig. 5-4) to shift the shade in panel 4. The shade shifted only 1 inch (it should have moved about 3.5 inches), and the lanyard broke.

Examination of the returned assembly showed that four screws in the slide frame extended too far, resulting in about 0.005-inch interference. This caused the shade to become jammed.

The assembly performed satisfactorily when deployed during the pre-flight fit and function check. However, it was necessary to refurbish the hardware after this operation, and the screw clearances may have changed as a result of the refurbishment.

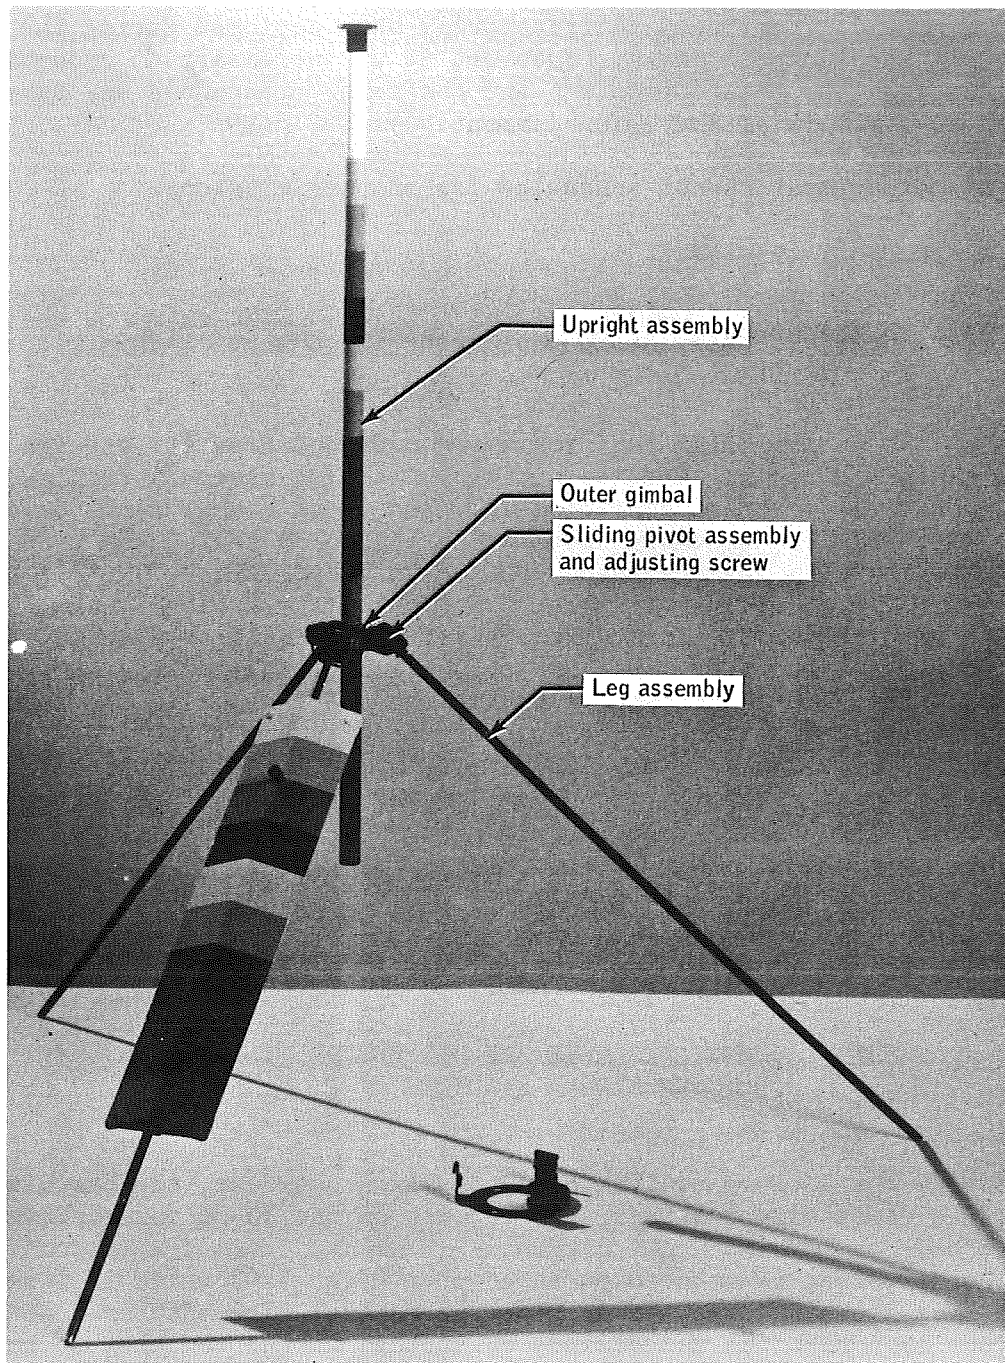
Figure 5-5.- Gnomon assembly.

When the gnomon (fig. 5-5) was being unstowed from its stowage bag during the second extravehicular activity, the leg assembly remained in the bag, and the vertical staff assembly and inner gimbal parts came out separately. The leg assembly, because of its color scale, was used during the rest of the lunar surface photographic operations.

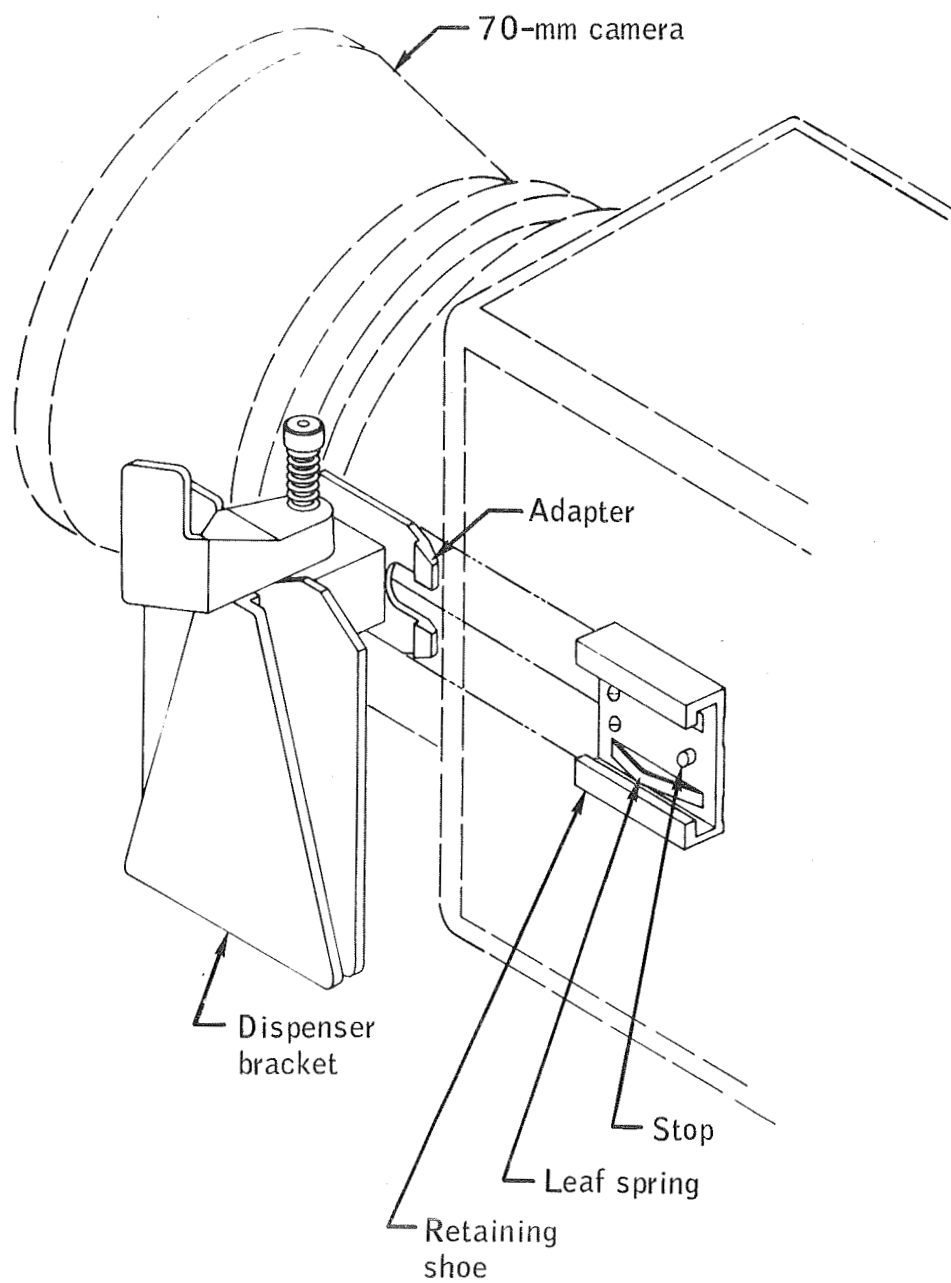
Figure 5-6.- Sample bag dispenser retention.

The dispenser is mounted on an adapter (fig. 5-6) which is inserted in the ring-sight tee-slot bracket on the camera. The adapter-to-tee slot interface is horizontal and depends on springs in the tee slot to hold the adapter in the latched position. This latching method is inadequate.

The adapter is being redesigned so as to provide a positive lock in the installed position.
